Portola Valley Home Energy Study Report

During March and April of 2008, energy evaluations were performed on five homes in Portola Valley. The findings are reported collectively below.

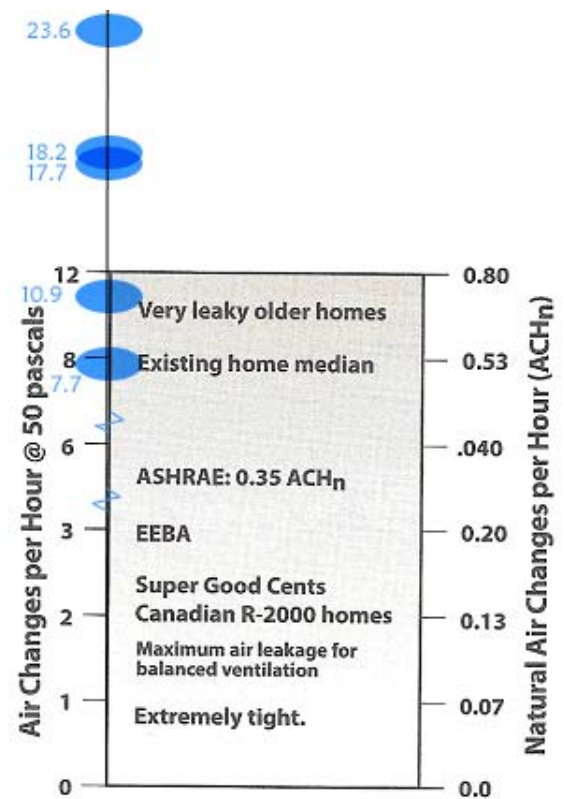
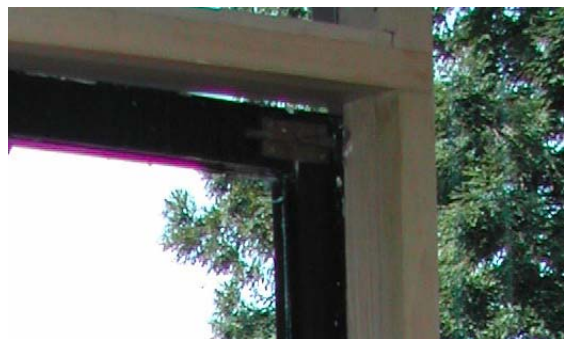
- A blower-door test was performed to measure overall air leakage of the homes and identify specific areas of leakage. Four of the five homes can be categorized as “very leaky”. However, one home’s air leaks are coming predominantly from its unducted air return; installation of a sealed return duct may result in that home performing substantially better on air leakage testing. A second home, if air leakage areas are corrected, could likely achieve “existing median” leakage or better.

Portola Valley homes indicated in blue. Underlying graphics © John Krigger & Chris Dorsi, Residential Energy (2004).

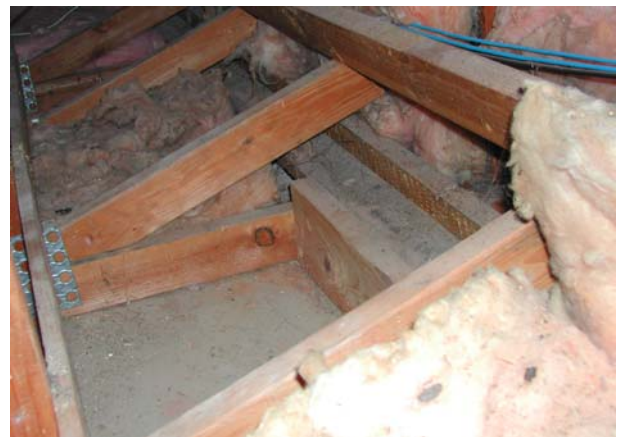
- Two of the five homes have accessible attic insulation consisting of fiberglass batts. The average insulation level is low, though – approximately R-12 in insulated areas. One home has a substantial number of misplaced or missing insulation batts. One home has a largely-uninsulated skylight shaft. Two homes do not have accessible attics but are believed to have insulation above the home.

Recommendation: Insulate accessible attics to at least R-38; if adding additional insulation, the marginal cost of insulating up to R-50 is relatively small, so R-50 is recommended. Existing attic batt insulation can be moved aside to

assure all openings are sealed, then the insulation batts replaced, and loose cellulose insulation can

be blown over the top of the older insulation batts. A netting enclosure can be constructed around skylight shafts in order to contain blown-in insulation and fully insulate the shaft. Drywall or plywood dams can be constructed to prevent loose-fill insulation from dropping onto horizontal attic hatches.

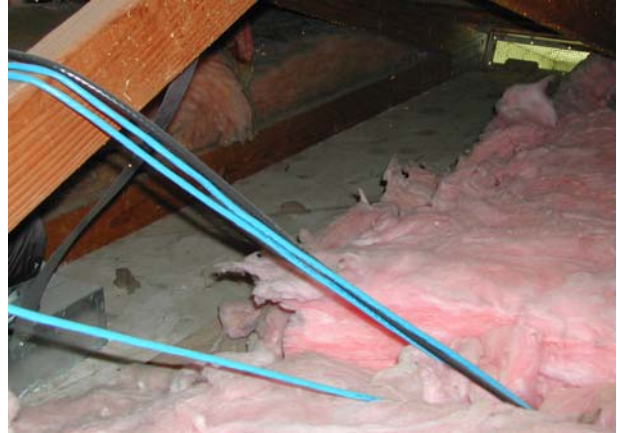
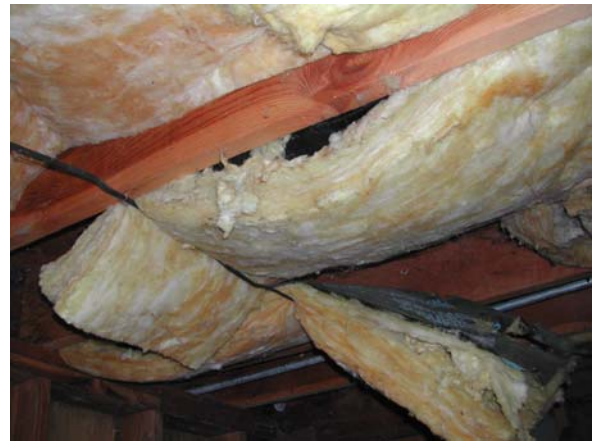
- Four of the homes have fiberglass batt insulation underneath the house. Three of the four homes had insulation batts missing or fallen from their intended locations. Recommendation: Re-attach or replace the missing or fallen insulation batts. Determine whether additional support is needed for other batts. Insulation batts must be in direct contact with the structure to be effective.

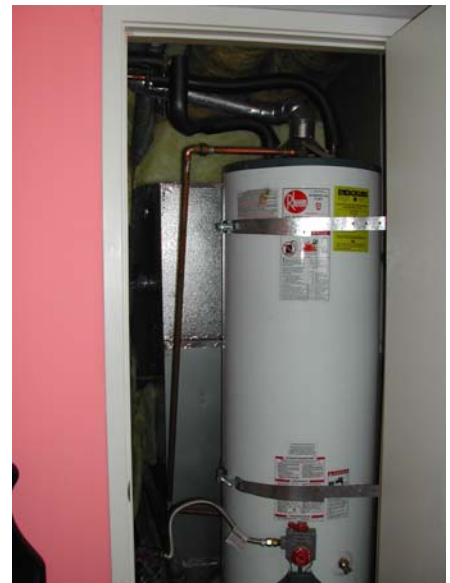
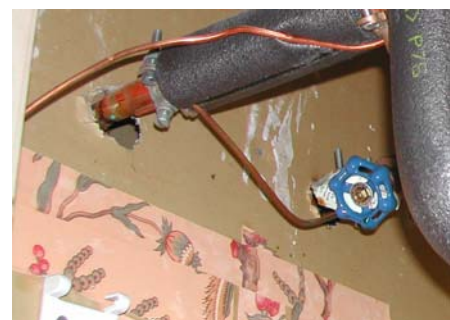
- Two of the homes have furnaces located in closet space inside the conditioned area of the home and utilizing air vents from the outside to provide combustion air. The ventilation grilles on one home’s utility closet are insufficiently sized and clogged with dust. Recommendation: Utility closets containing combustion equipment should be considered “outside space” and should have floor, wall, ceiling, and door sealing and insulation between the closet and the conditioned areas of the home. At the same time, it must be assured that the venting and grilles providing the combustion air are sufficiently sized and kept clear and clean in order to avoid choking the combustion flame, which would decrease combustion equipment efficiency and increase the production of carbon monoxide.

- Two of the three homes have uninsulated air handler plenums. Recommendation: Air handler plenums (the metal boxes just before and after the furnace) should be sealed with mastic, or less preferably with metal tape, and should be insulated with fiberglass batts or fiberglass ductboard.

- Four of the five homes have unsealed plumbing and/or ducting penetrations between the utility area and the conditioned portion of the home. Recommendation: Seal duct, plumbing, and electrical penetrations from both the exterior and interior areas to reduce air leakage.

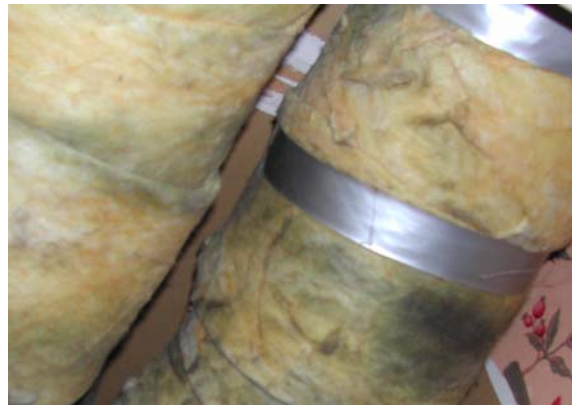
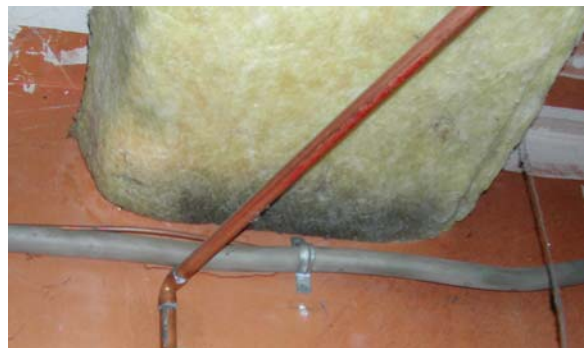
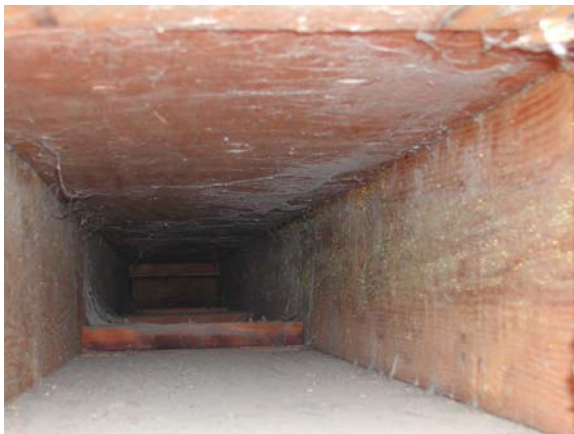
- Analyzed homes with heat ducts have moderately to extremely leaky duct systems. Bands of discoloration on duct insulation at one home show locations of duct leaks. Recommendation: An HVAC contractor should use mastic to seal all seams and connections in the air ducts and plenums. An alternative to using mastic to seal from the outside is the Aeroseal duct sealant system, in which aerosolized adhesive is blown into the duct system to seal leakage from the inside. The HVAC contractor should also seal all duct "boot" connections to the walls and floors where they enter the home.

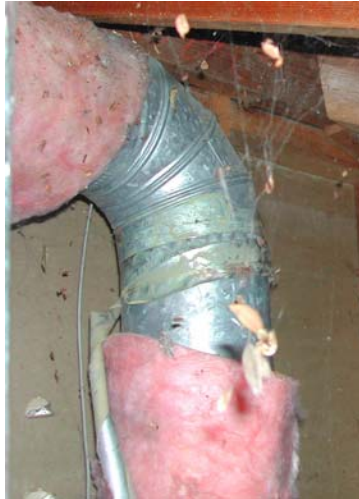
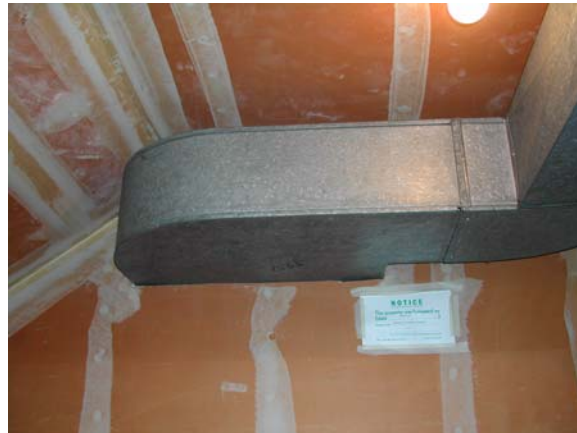
- Two of the homes have fully or partially unducted returns: the return air travels from the interior of the home through a wall cavity back to the furnace instead of traveling through a sealed and insulated

duct. The unducted returns allow substantial air infiltration, provide no insulation to preserve existing air temperature, and may introduce outside air or crawl space air into the return air system. Recommendation: Retrofit unducted returns with sealed and insulated return ducts.

- All four homes with ducted heating have insulation on most of the heat ducts, but all four also have areas where duct insulation is missing or has fallen off. Recommendation: An HVAC contractor, after sealing the ductwork, should install or re-install fiberglass insulation on all ducts and plenums.

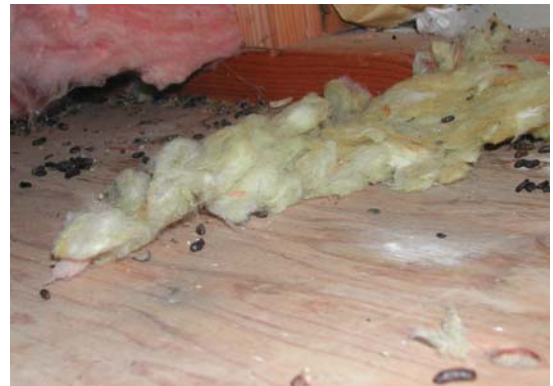
- Three homes have unintentional wildlife access openings to the crawl space, and two of the homes have wildlife droppings visible in the crawl space. Recommendation: Because the air from the crawl space often rises up into the home, preventing that air from becoming contaminated with wildlife droppings is important. Wildlife in the crawl space can also damage insulation, wiring, and other building elements in the crawl space. Assure vents and other openings are sufficiently screened or blocked, set traps to remove intruding wildlife, and remove wildlife droppings from the crawl space at least annually.

- One home has substantial moisture in the crawl space, and a second home had one area of moist soil in the crawl space at the time of the inspection. Recommendation: After removing any wildlife droppings and addressing drainage issues, cover crawl space soil with 6 mil poly sheeting, overlapping several inches at the seams, to reduce water vapor evaporating into air that enters the home.
