Portola Valley Home Energy Study Report

During March and April of 2008, energy evaluations were performed on five homes in Portola Valley. The findings are reported collectively below.

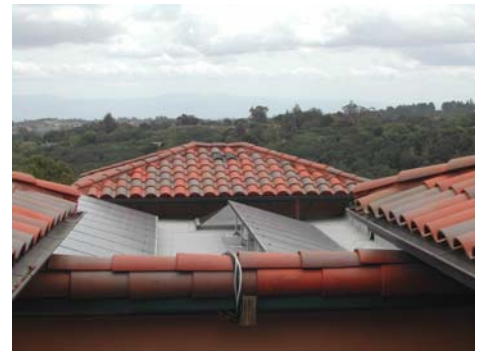
- One of the three homes has a photovoltaic system producing electricity. Recommendation: If electric bills are over \$150 per month, consider installing a photovoltaic system to produce electricity if the home's shading and roof configuration are appropriate. For the home using 1,200-2,500 kWh per month, the pay-back time on a properly-sized system should be appealing.

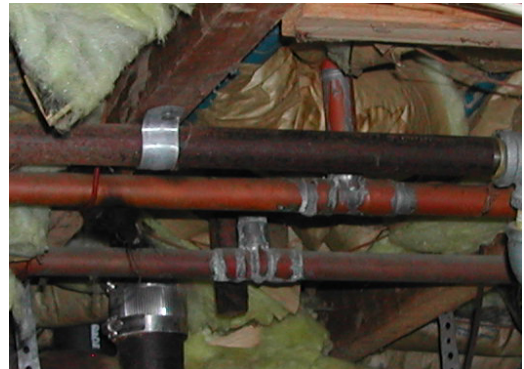
- None of the homes has a solar thermal hot water heating system for domestic hot water. One of the homes has a solar thermal system for heating pool water. Recommendation: Consider installing a solar thermal system to heat domestic hot water. If the home has a pool that is heated, it should have a solar water heating system for the pool.

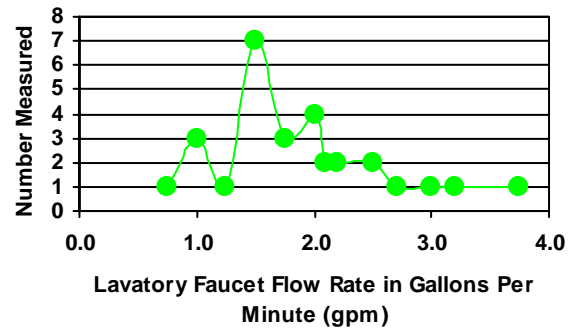
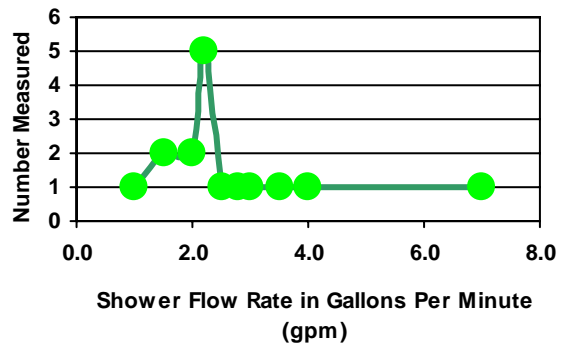
- Of the 16 showerheads analyzed, 5 provide flow greater than 2.5 gpm. Recommendation: All showerheads now manufactured in the U.S. must restrict flow to 2.5 gallons per minute (gpm) or less. Replace any using more than 2.5 gpm.

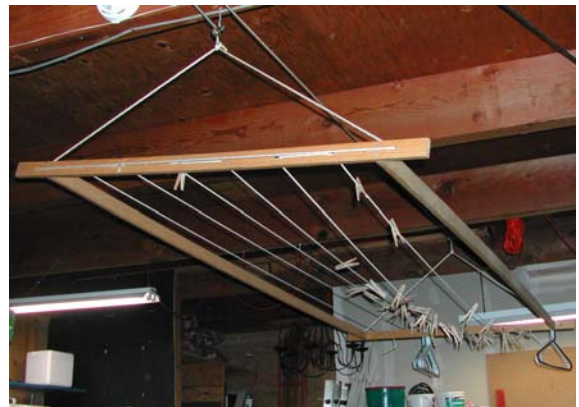
- One home uses 50% hot/cold laundry loads and 50% cold/cold loads. Two homes use mostly or completely cool/cool. Recommendation: Use cold water for all washing except white loads; use warm wash and cold rinse for white load if warm water is necessary.
- Three homes use efficient front-loading washing machines and the other two homes use top-loading models. Recommendation: Replace top-loading washers with Energy Star labeled front-loading models, to save on water, energy to heat wash water, and energy to dry the damp clothes.
- One homeowner drip-dries all laundered clothes instead of using a dryer. Recommendation: Drip-drying is a great way to save energy. To avoid adding to the moisture load of the home, try to drip-dry clothes outside or in a garage area.
